TEMPESTE ESTREME

SICUREZZA DELLE STRUTTURE PORTUALI: INFLUENZA DELLE ONDE ESTREME

Guido Benassai

Dip. Di Ingegneria, Università di Napoli Parthenope

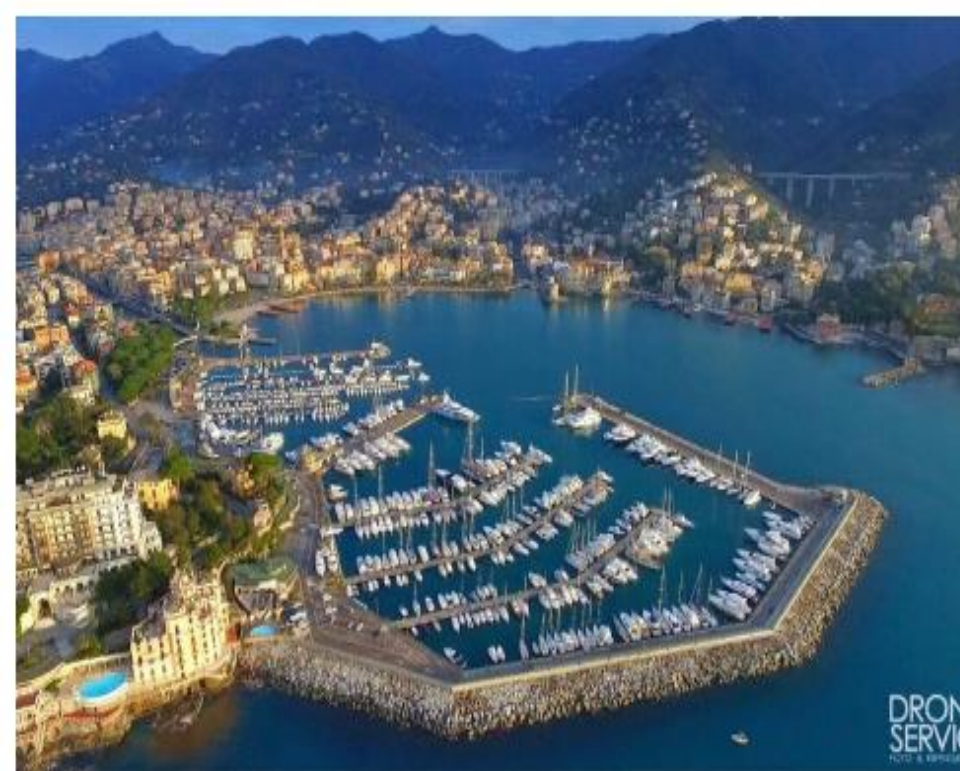
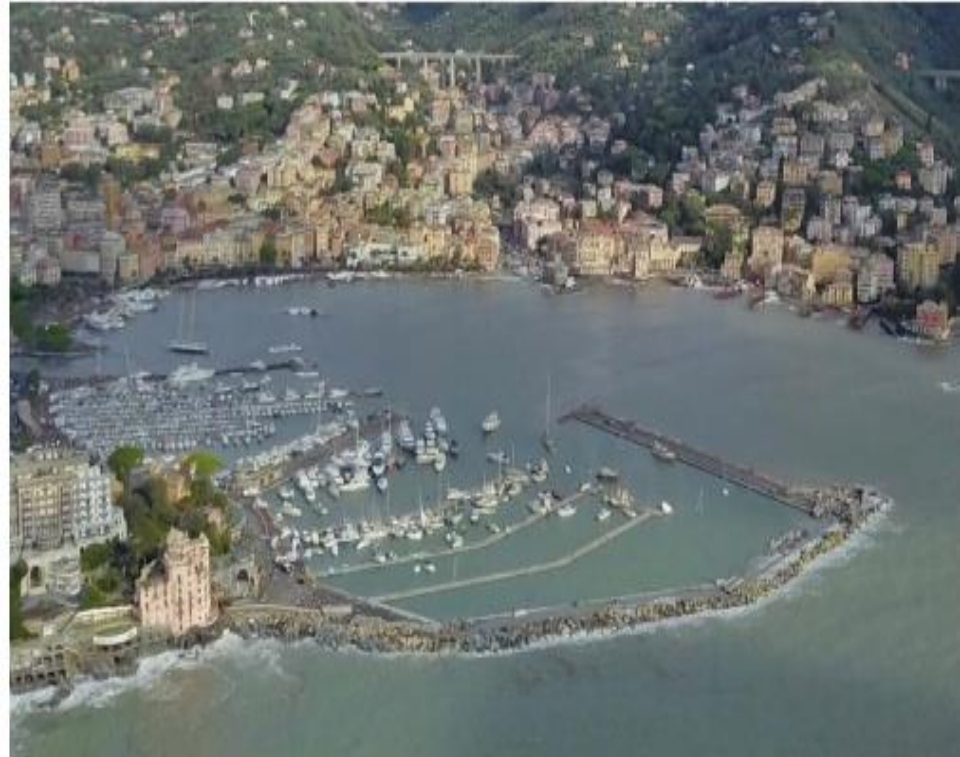
Danni riportati dall'evento 29-31 ottobre 2018: Pre-post evento Porto di Rapallo

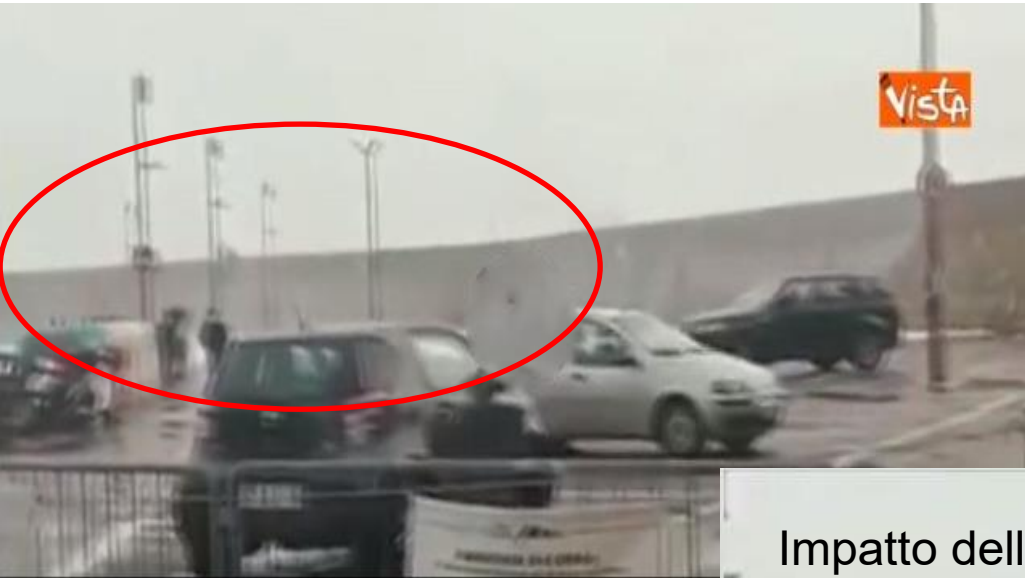
Prima dell'impatto
dell'onda

**Danni prodotti dalla mareggiata VAIA
sulla diga foranea del porto di Rapallo**

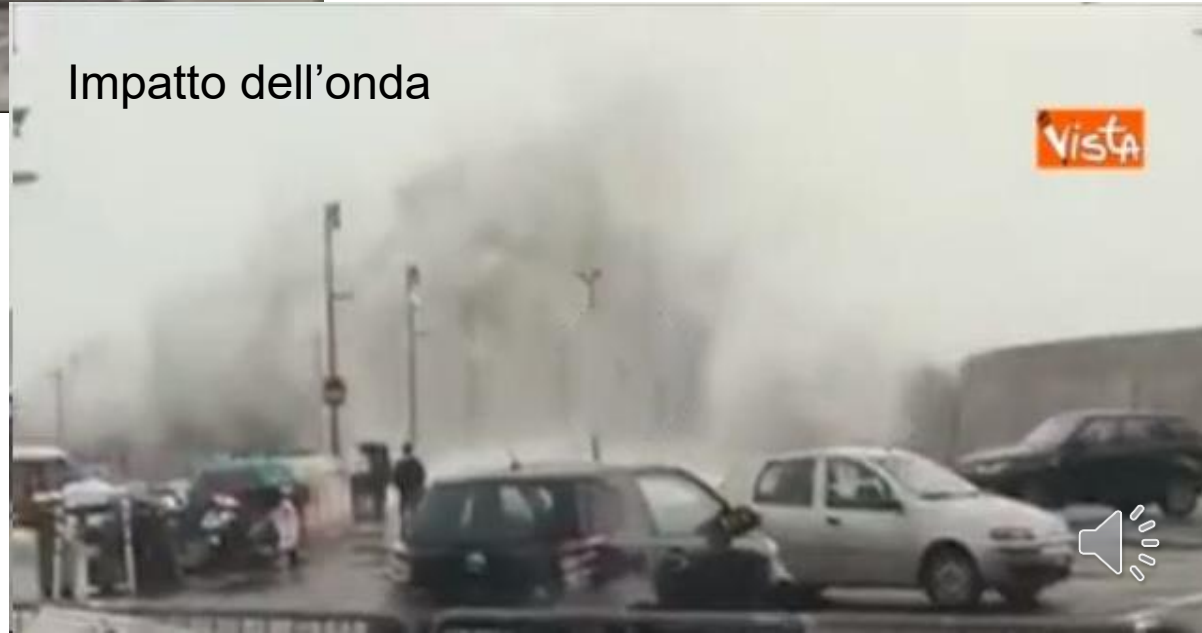
Impatto dell'onda

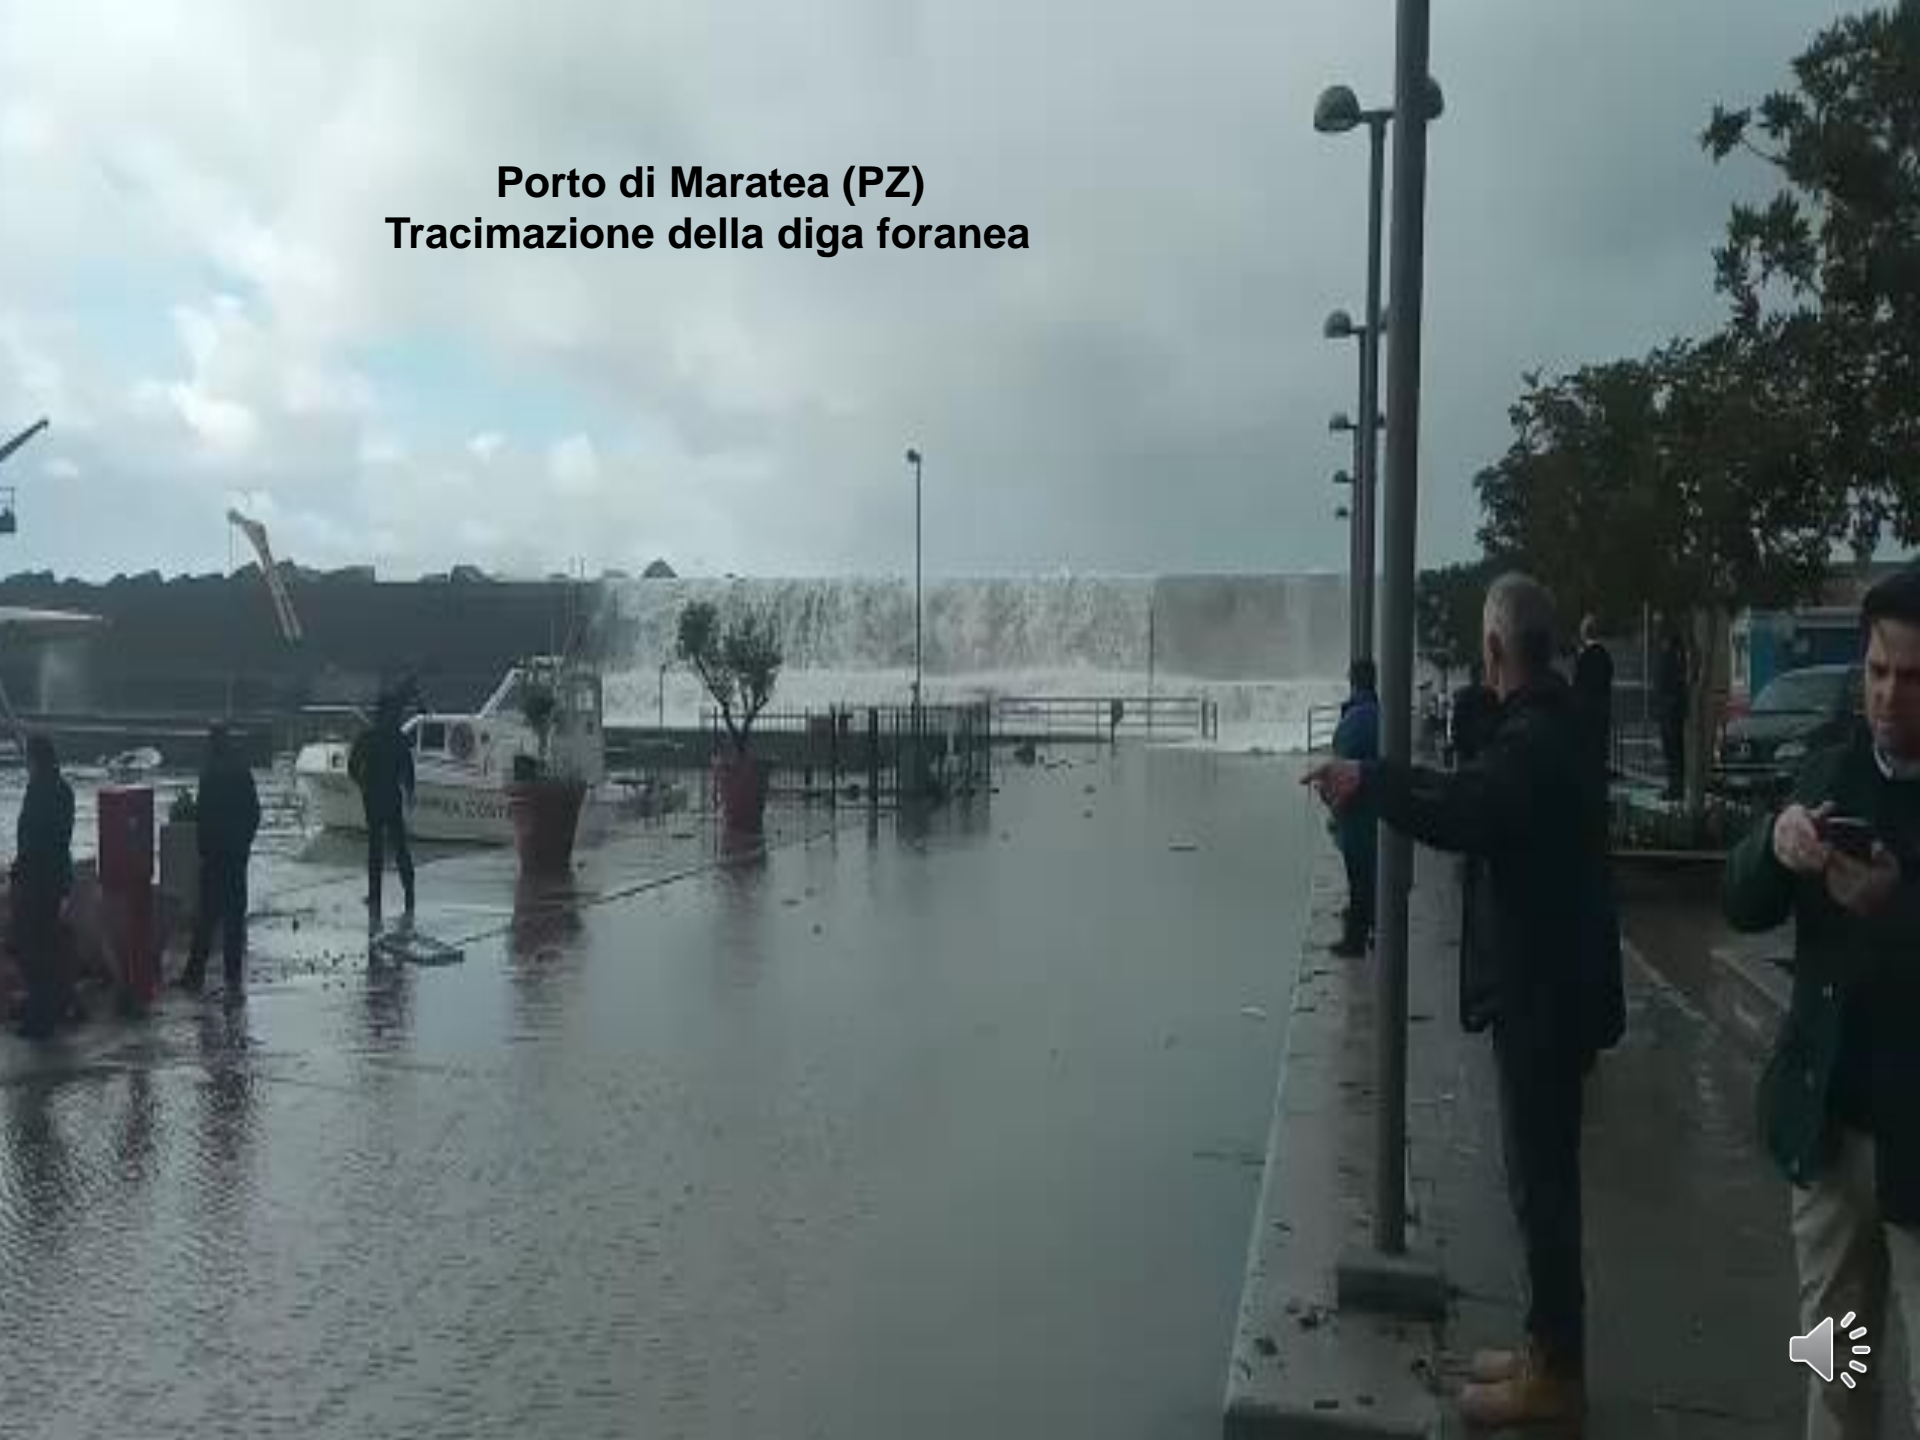
**Porto di Maratea (PZ)
Tracimazione della diga foranea**

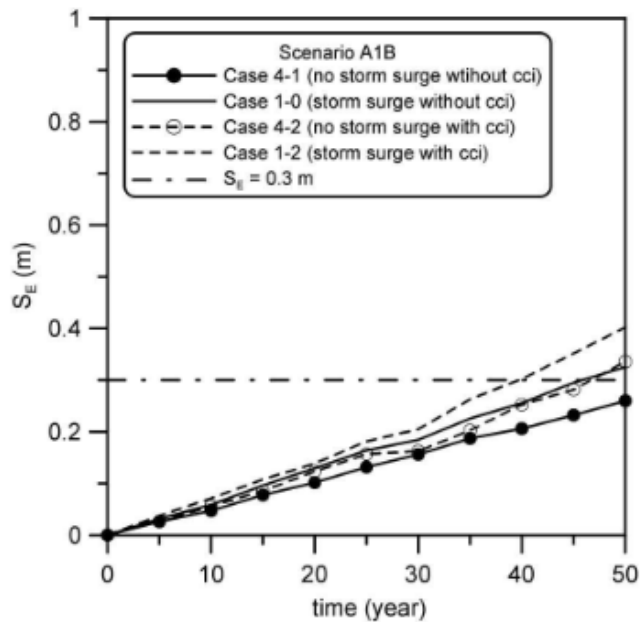
Fig. 7. Temporal variation of expected sliding distance for Case 4 (influence of storm surge)

With a tidal range of $\Delta\eta = 1.5$ m, the tide level η_t was simply assumed to vary sinusoidally between low water level (LWL) ($\eta_t = 0$) and high water level (HWL) ($\eta_t = \Delta\eta$). For simplicity, the effect of storm surge was taken into account by adding 10% of the deep-water significant wave height to the tide level (Shimosako and Takahashi 1998; Kim and Takayama 2003). This assumption corresponds to the wind set-up change owing to extreme wind stress change. Because the increase of wave height owing to climate change is taken into account, the influence of climate change on storm surge is also taken into account indirectly.
